NEWS RELEASE

March 14, 2013

New crash tests: Underride guards on most big rigs leave passenger vehicle occupants at risk in certain crashes

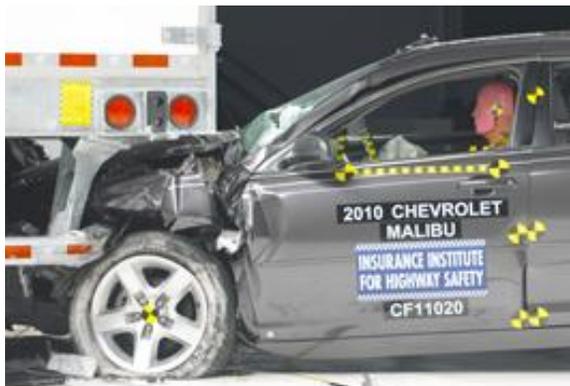
The underride guard on the Manac trailer, above, was the only one of eight tested to prevent underride in a 30 percent overlap crash. The performance of the Utility trailer, below, was more typical.

Manac, the only trailer to pass the 30 percent test, takes a different approach. The supports of its underride guard are attached to a reinforced floor and spaced just 18 inches from the edge. The Malibu and the dummy inside it not only fared better, but the Manac trailer also had damage estimates among the lowest of all the trailers. It required only a replacement underride guard.
